Rimkus Consulting Group, Inc.
Eight Greenway Plaza, Suite 500
Houston, TX 77046
(800) 580-3228 Telephone
(713) 623-4357 Facsimile

Re: RCG File No: 11009971
LLV Number: 0209452
VMF Location: 1530 Greensmark Drive in Houston, Texas
Subject: Final Report

Rimkus Consulting Group, Inc. was retained to examine LLV 0209452, VIN 1GBCS10E4M2908832. The fire occurred on June 13, 2016 at around 12:30 P.M. the operator of the vehicle at the time of the fire, was unavailable for interview but reportedly stated the vehicle's engine died while delivering mail on his route and backfired during subsequent attempts to restart it. Soon thereafter, smoke was observed from beneath the hood as well as flames.

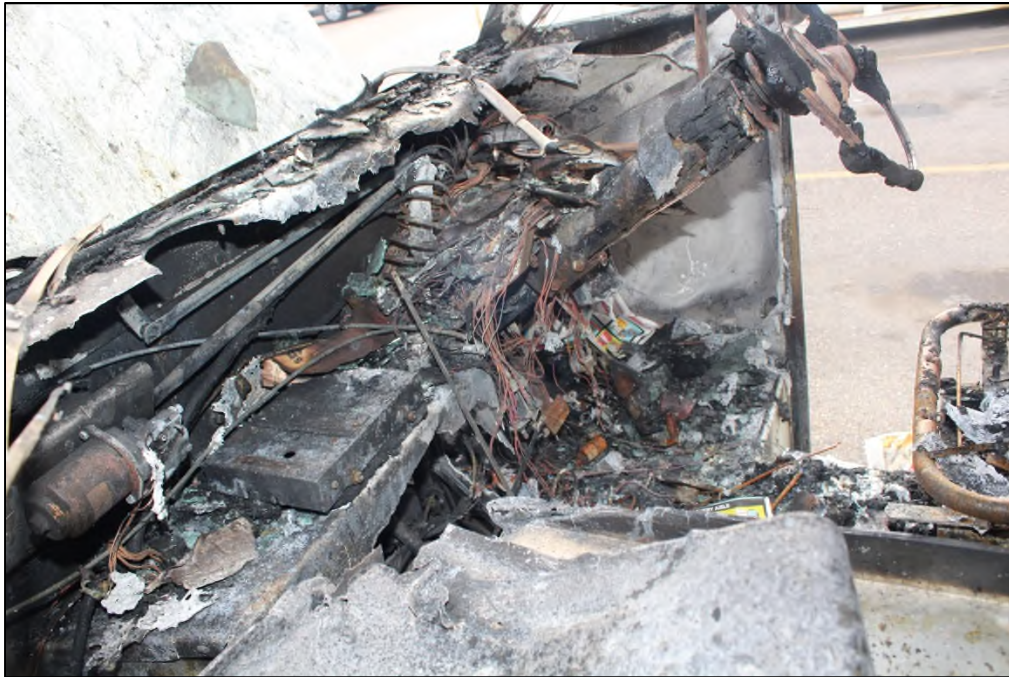
1. The fire originated in the area of the driver's side dashboard of the vehicle.
2. The specific area of origin could not be conclusively determined at the time of our examination due to the severe fire damage to the driver's side and the lack of remaining physical evidence for examination.
3. The specific ignition sequence and cause of the fire could not be conclusively determined at the time of our examination due to the severe fire damage to the vehicle and the lack of remaining physical evidence for examination; however a failure of the Rheostat headlight switch could not be eliminated.

Based on the fire patterns observed, it was determined the fire initiated within the interior compartment in the area of the driver's side dashboard then progressed throughout the interior compartment and through the windshield and bulkhead.

Photograph 9
Dashboard area of origin.

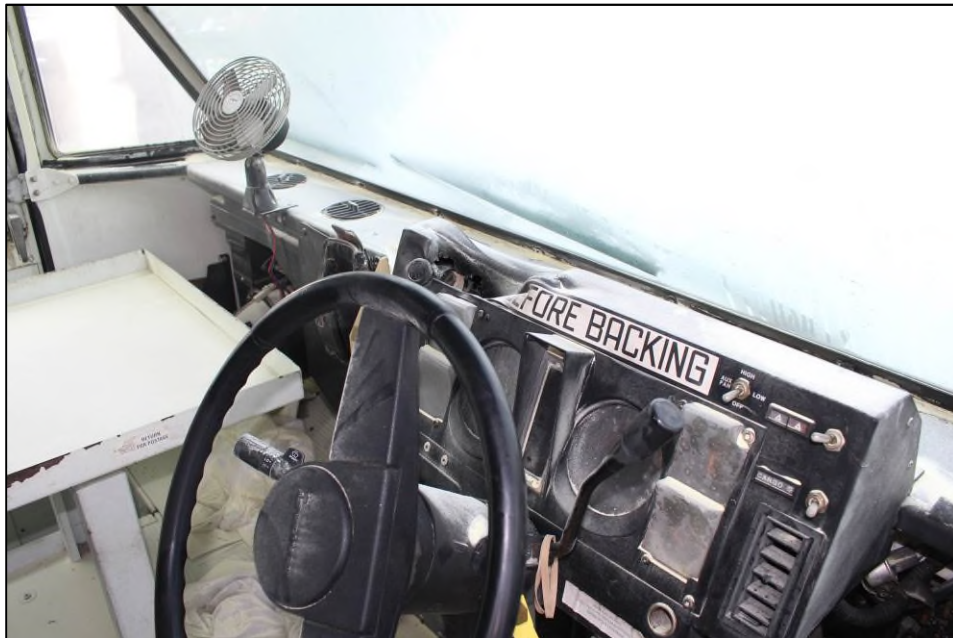
Photograph 6
Melted dashboard.

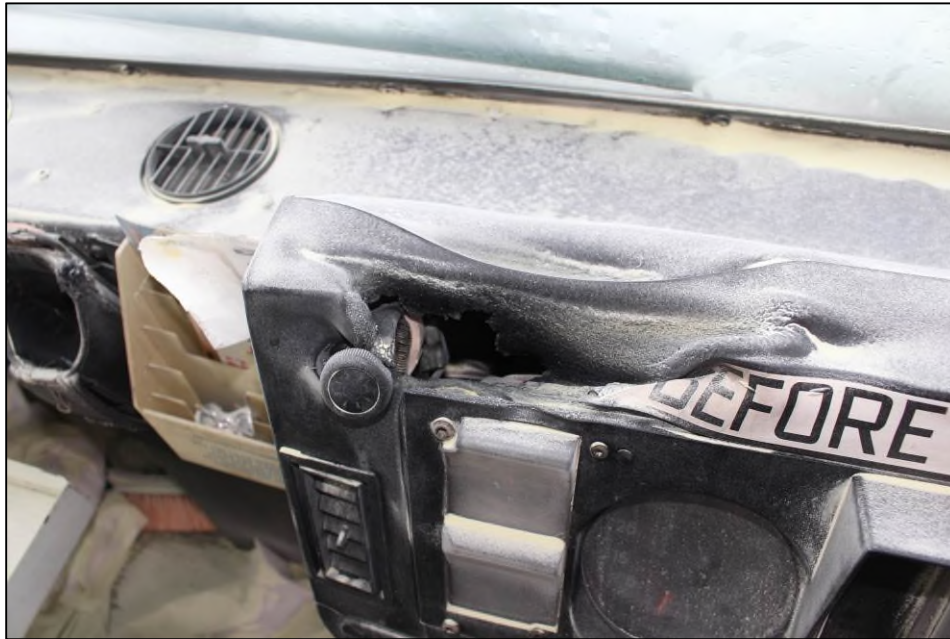
Photograph 7

Melted dashboard near head lamp switch.

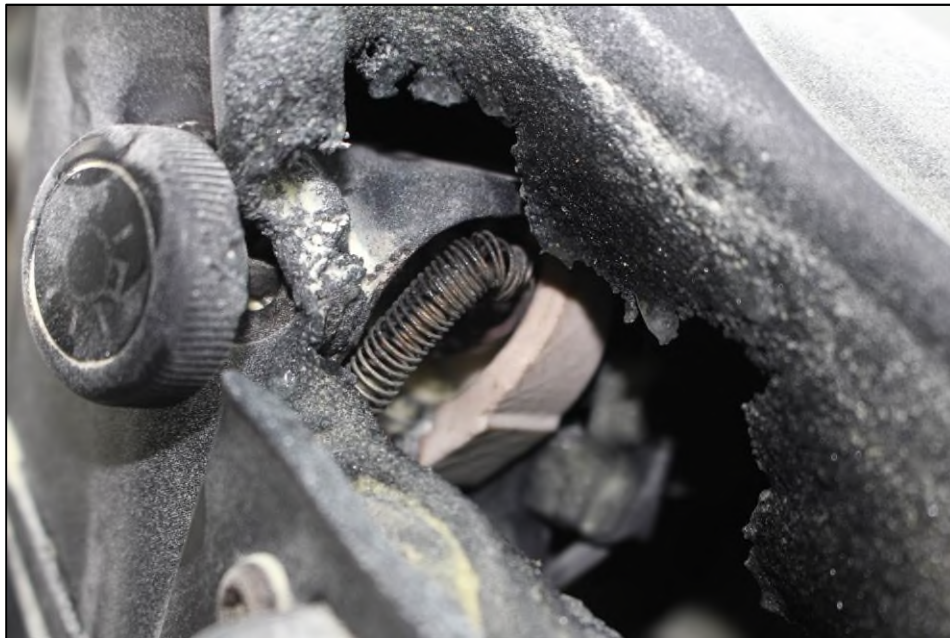
Photograph 8

Headlamp switch inside dashboard.

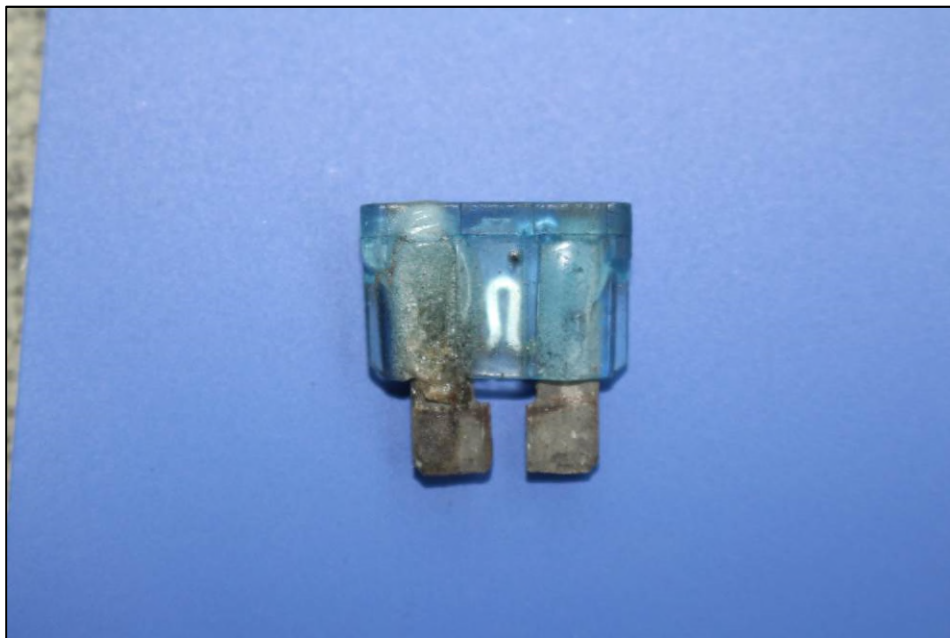
Photograph 12
Damaged/melted to fuse.

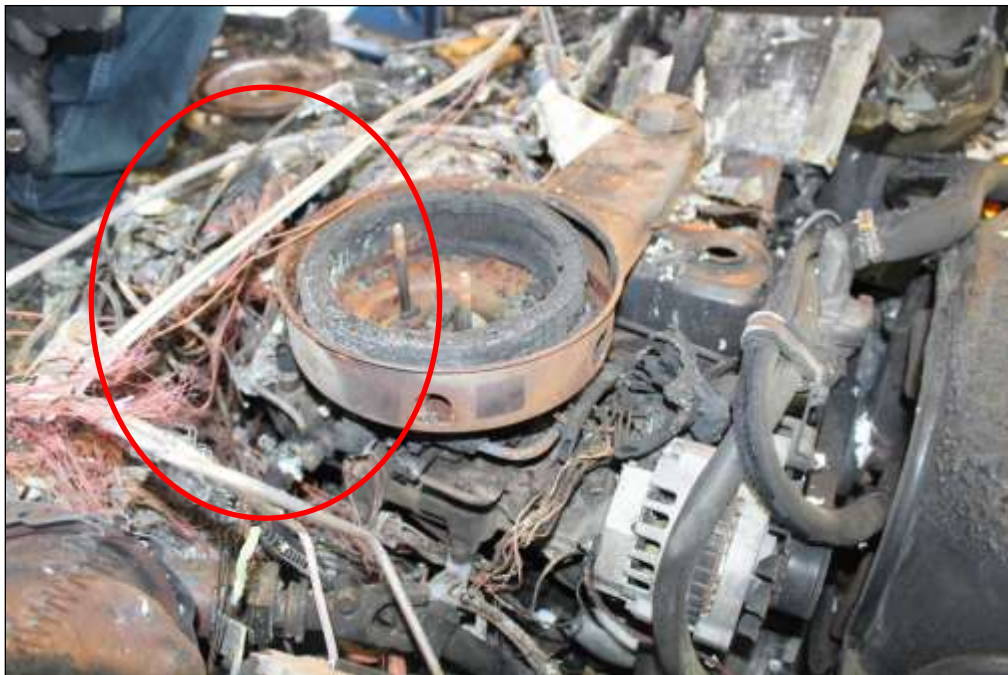
Photograph 4
Area of the fire's occurrence.

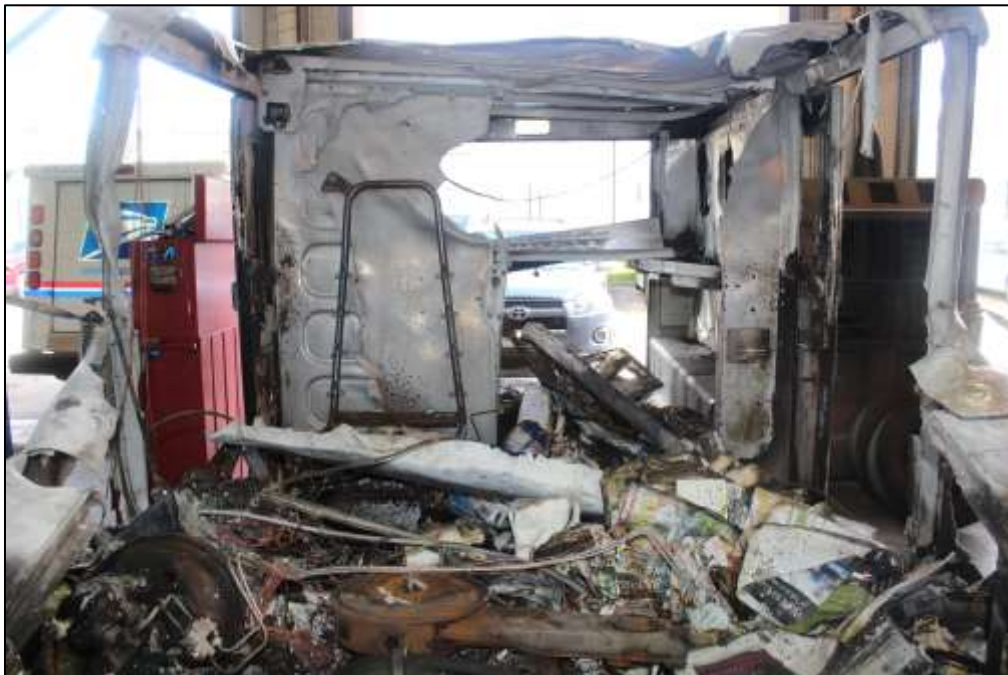
Photograph 6
Interior compartment from engine compartment area.

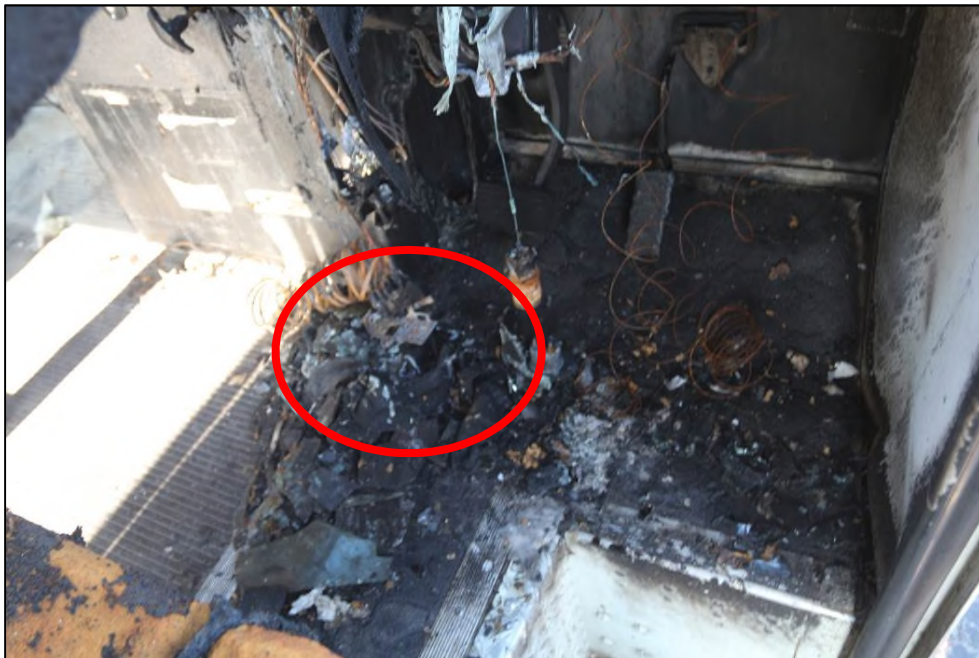
Photograph 6

A view of the headlamp switch found in the debris on the floorboard.

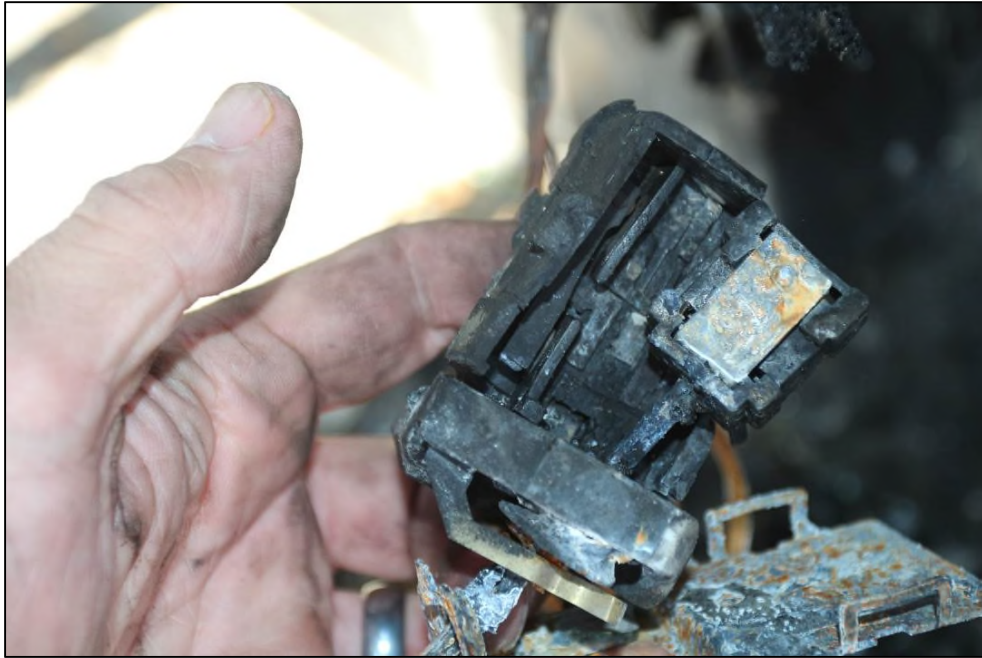
Photograph 7

A view of the damaged headlamp switch.

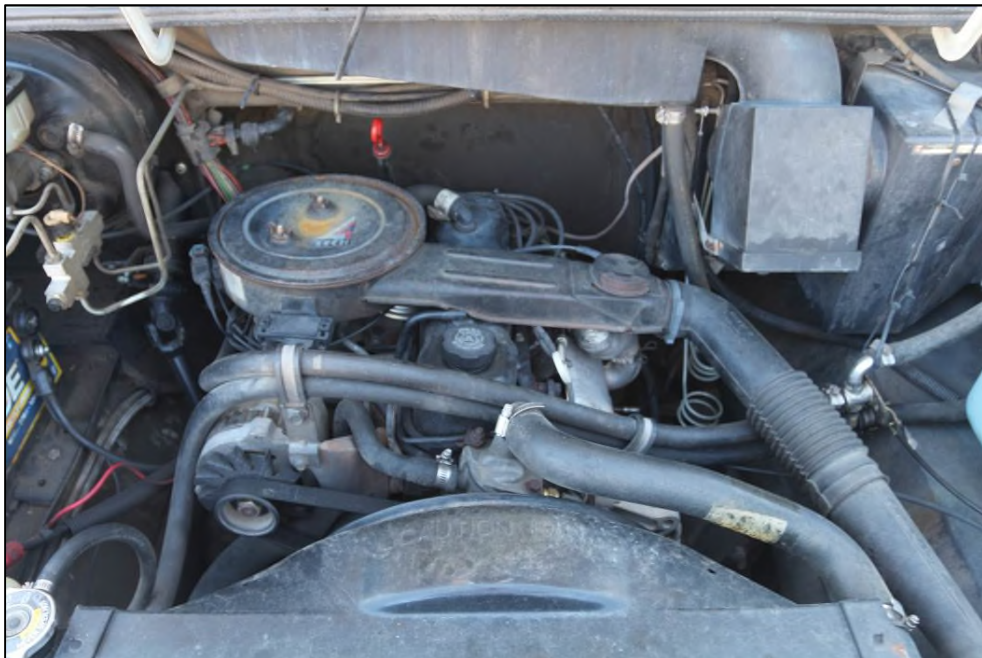
Photograph 8

A view of the undamaged engine compartment.

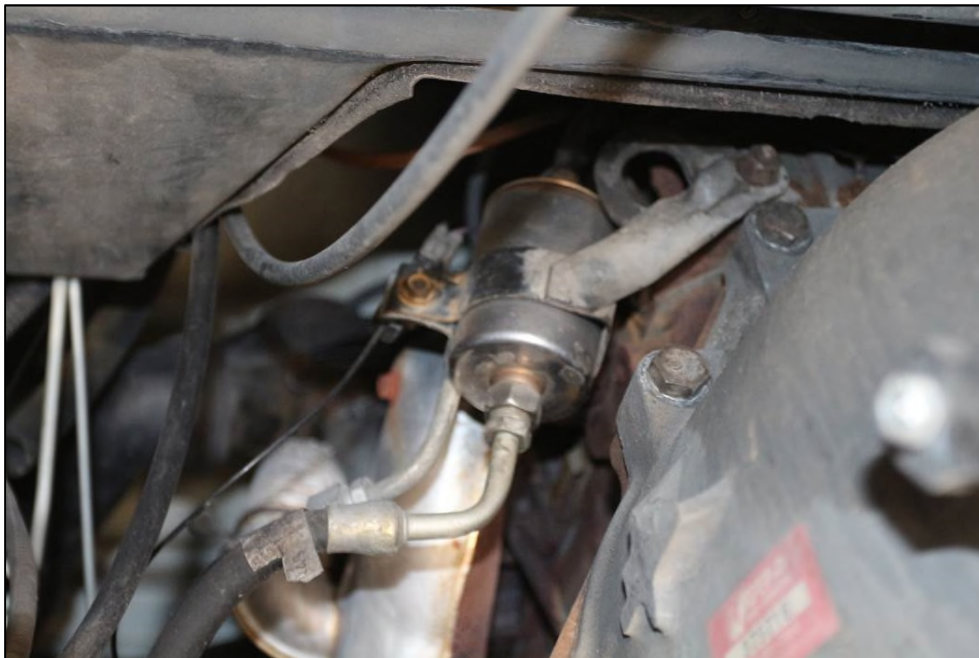
Photograph 10

A view of the undamaged, in-line fuel filter.

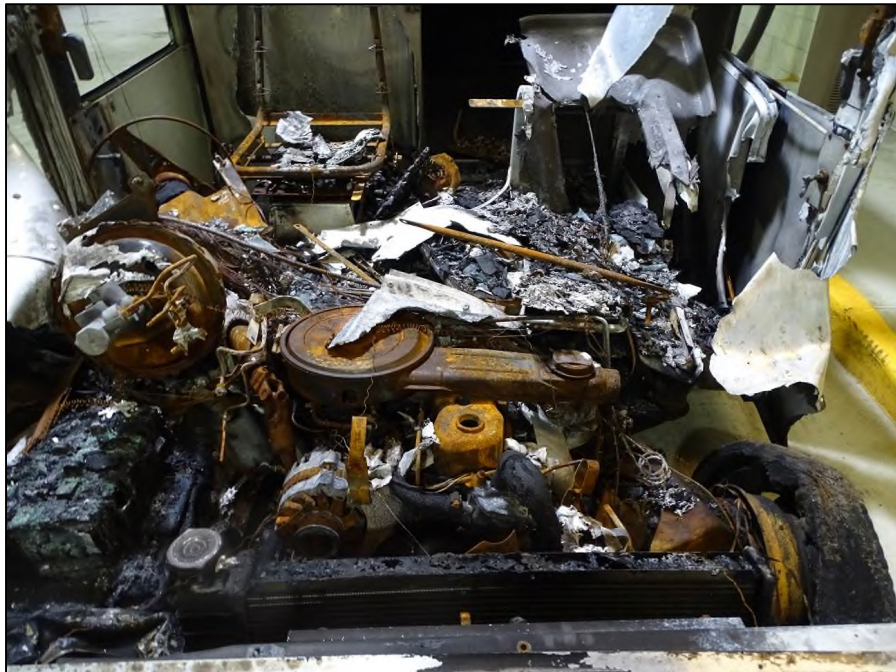
Photograph 2

Fire damage in the engine compartment was more extensive on the left side of the vehicle. We examined the electrical conductors and observed no adverse electrical activity. We observed that the rubber fuel lines had been consumed by the fire. Burn patterns on the left side of the engine indicated the fire extended up from the exhaust manifold and pipe. We examined the exhaust pipe. We observed patterns indicating a liquid had run down the exhaust pipe.

Overall view of the engine compartment.

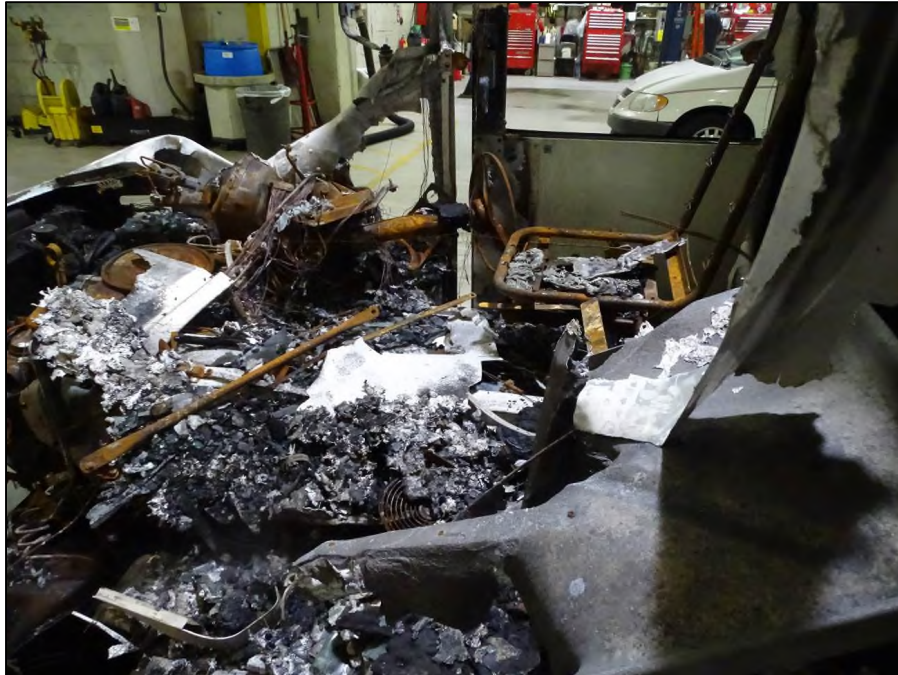
Photograph 3

Examination of the interior of the vehicle revealed extensive fire damage throughout. The steering column had collapsed. The dashboard had been consumed by fire. The left side of the firewall had a large opening where the heater core would have been. Burn patterns within the interior indicated that the fire entered the passenger compartment from the engine compartment.

Overall view of the passenger compartment.

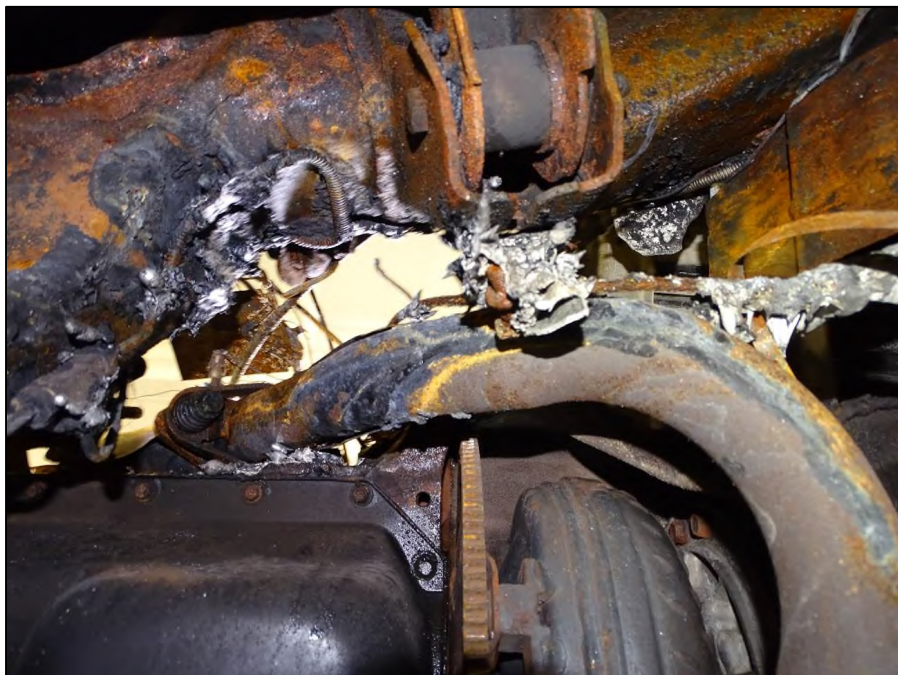
Photograph 4

Patterns on exhaust pipe.

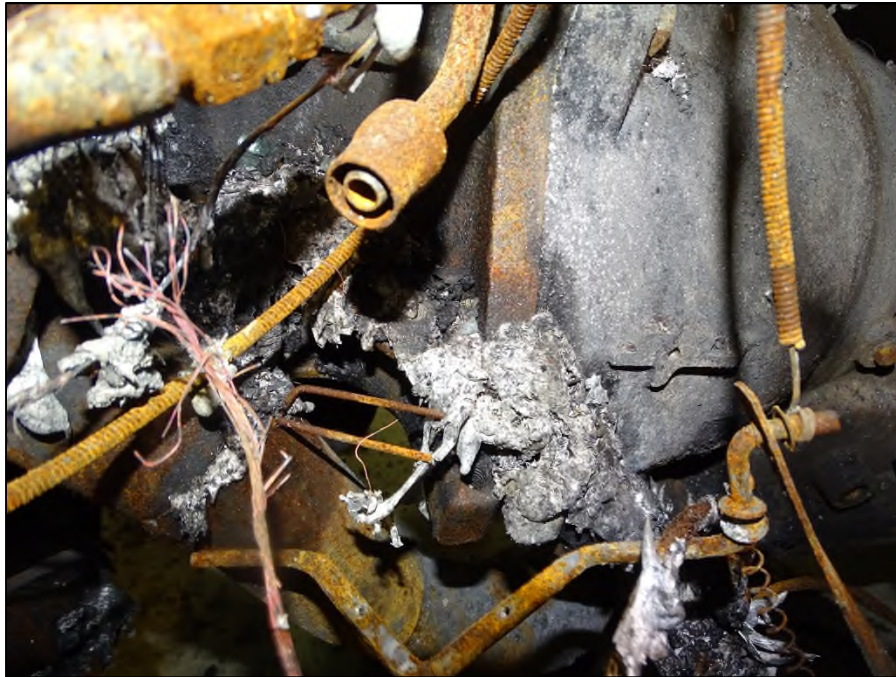
Photograph 5

The fuel lines on the left side of the engine compartment.

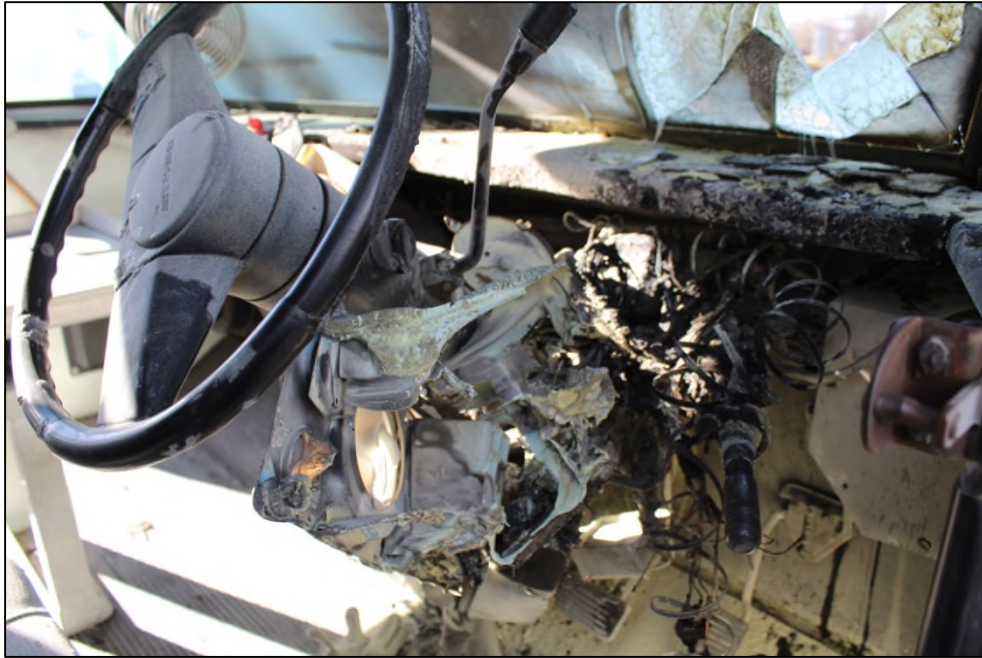
Photograph 7

View of the dash – area of origin.

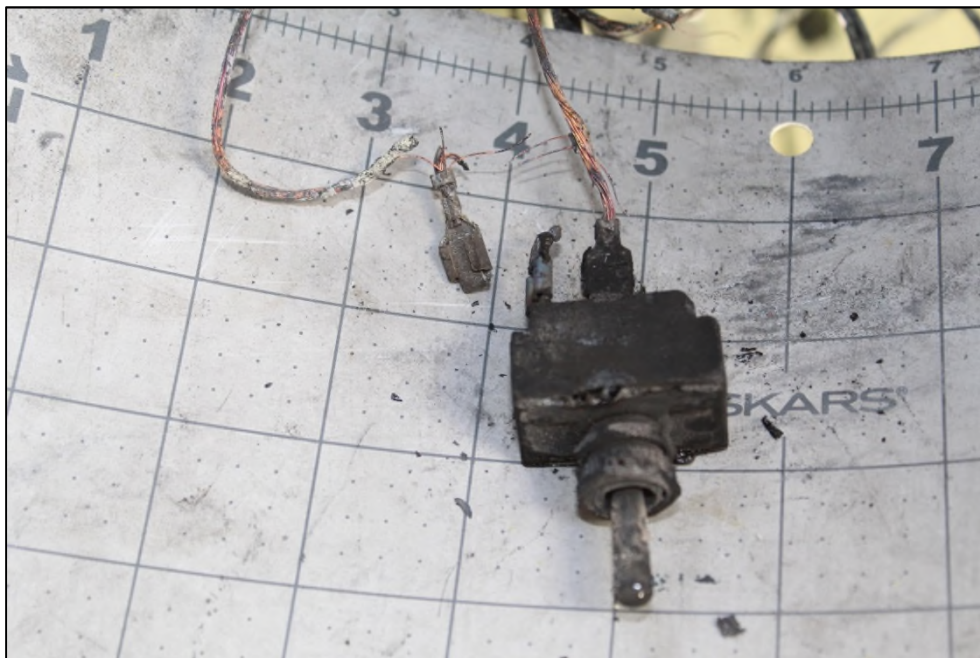
Photograph 10

Close-up view of the switch responsible for the fire.

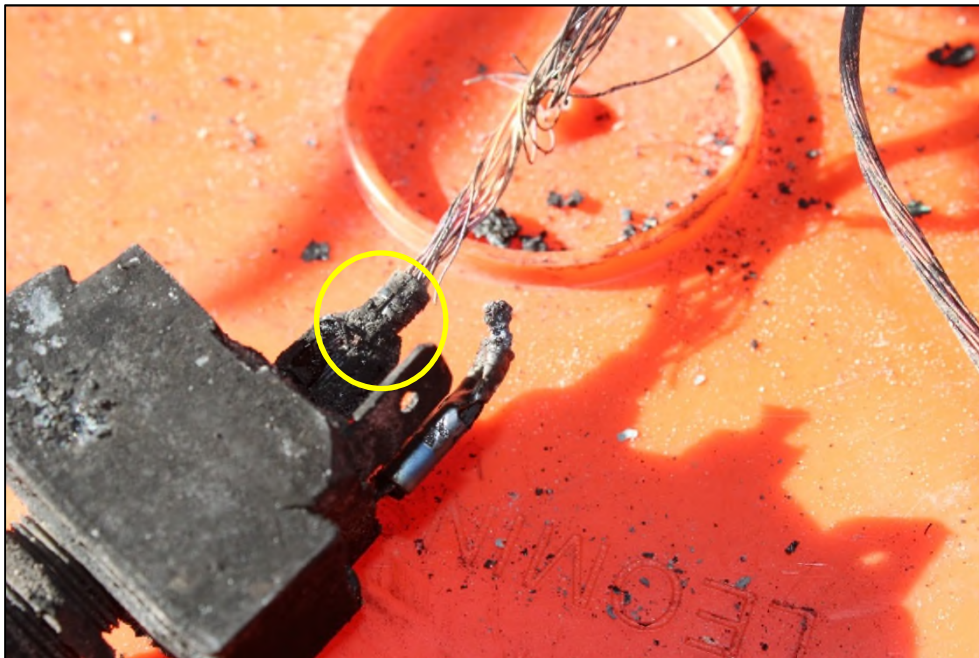
Photograph 12

View of the connector with a loss of mass to the wiring.

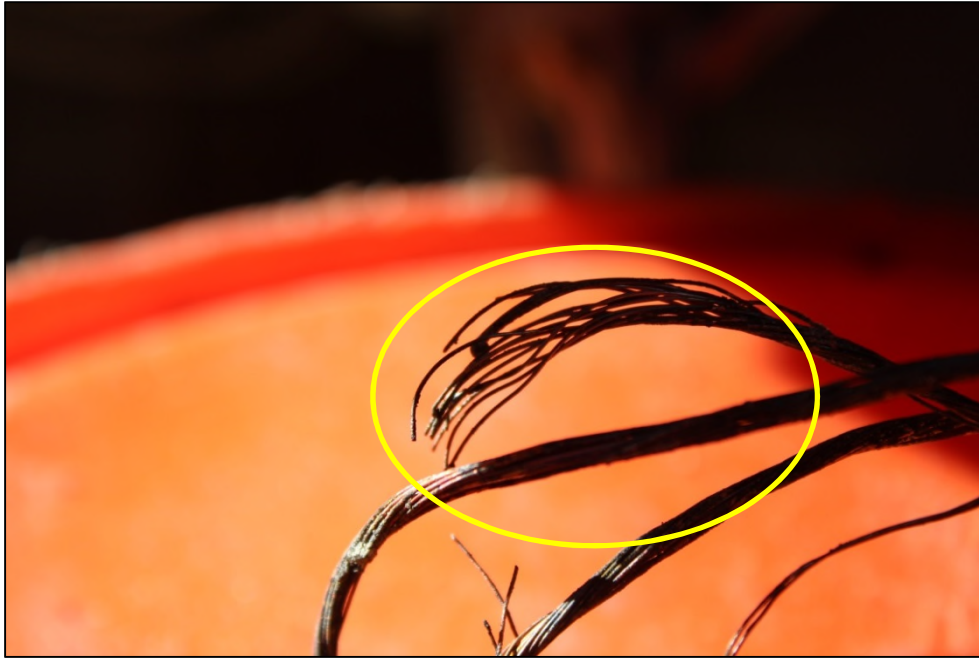
Photograph 13

View of the opposite end of the wire where the loss of mass occurred.

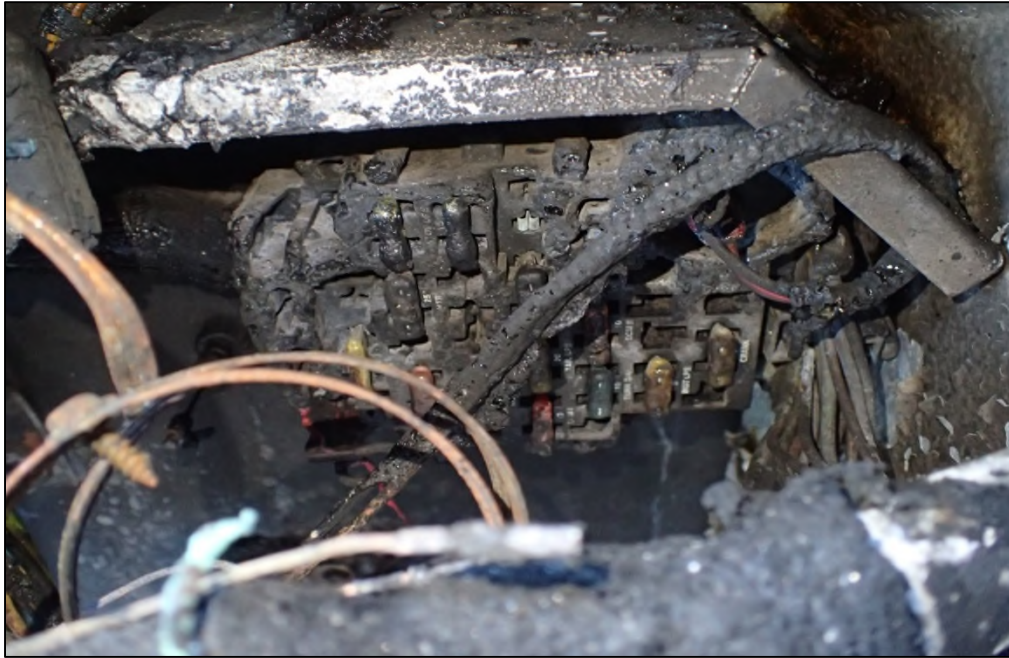
Photograph 5

A view of the fire damaged fuse panel.

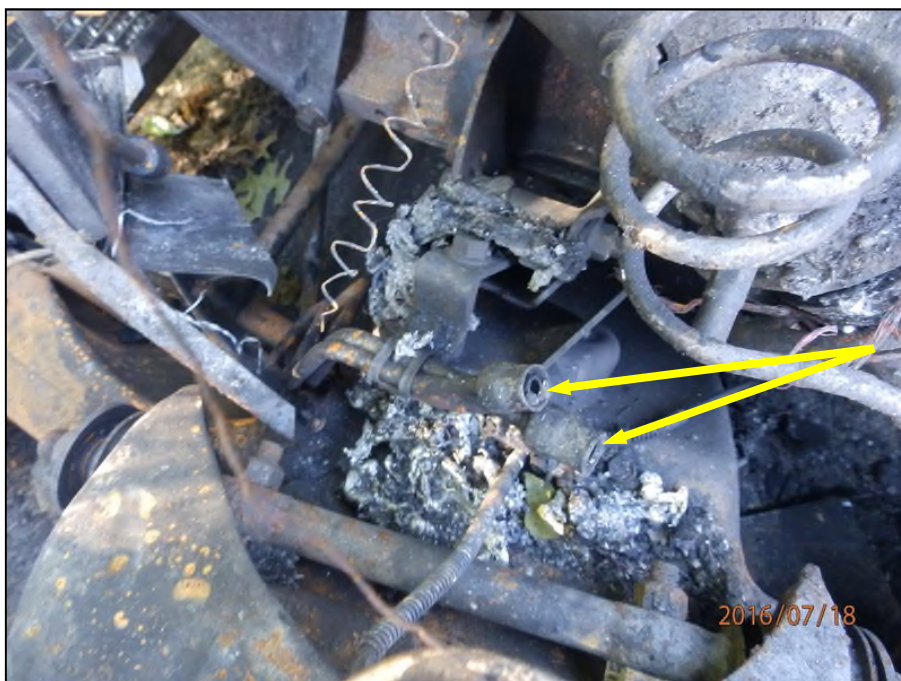
Photograph 4

A view of the position of the consumed flexible fuel lines.

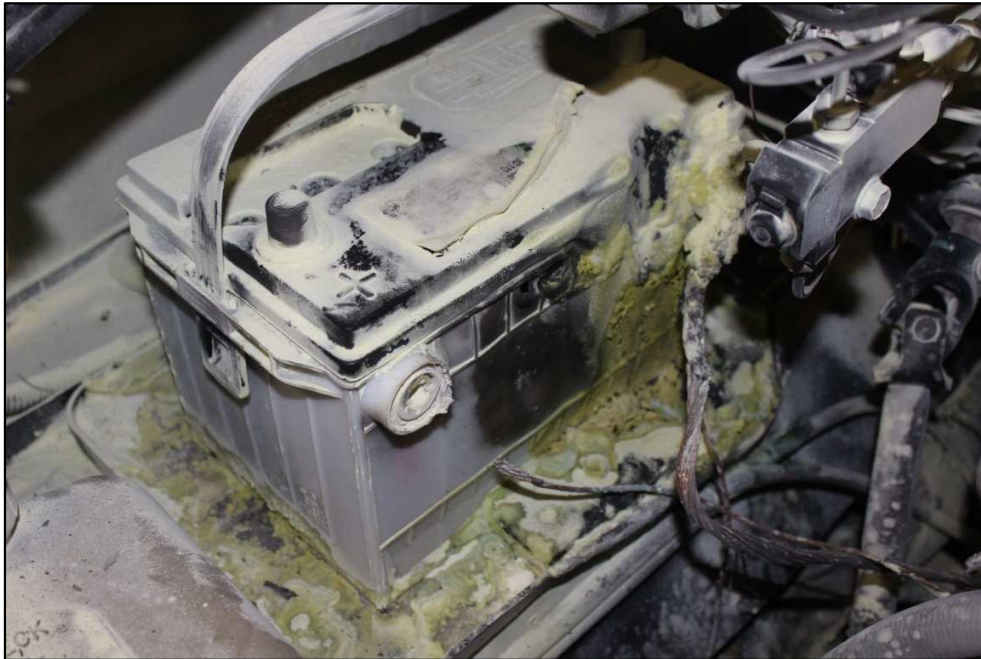
Photograph 3

Fire damaged side of the battery.

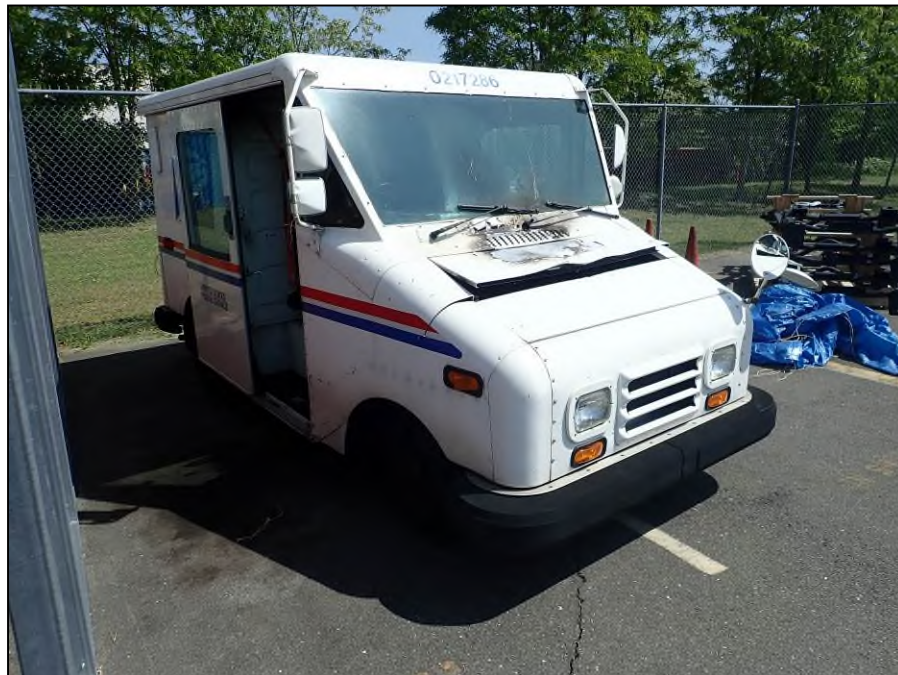
Photograph 2

Right front side.

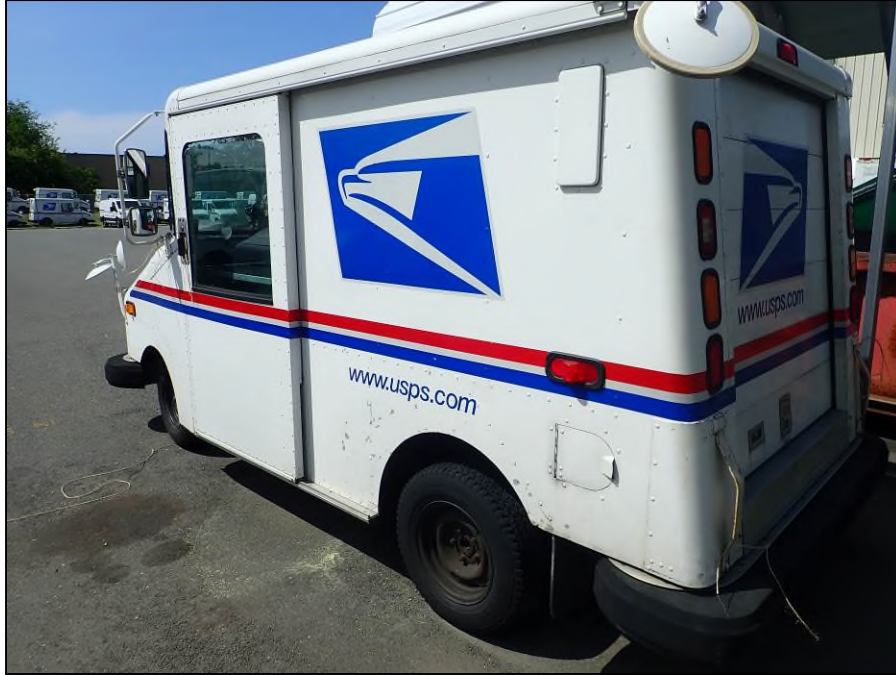
Photograph 3
Left rear side.

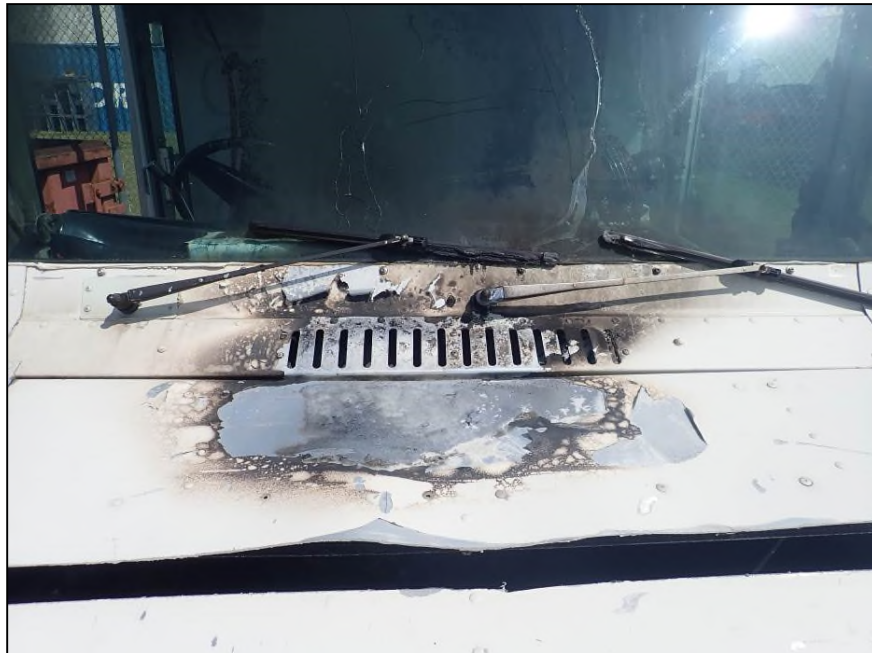
Photograph 4
Fire damage to hood along bulkhead.

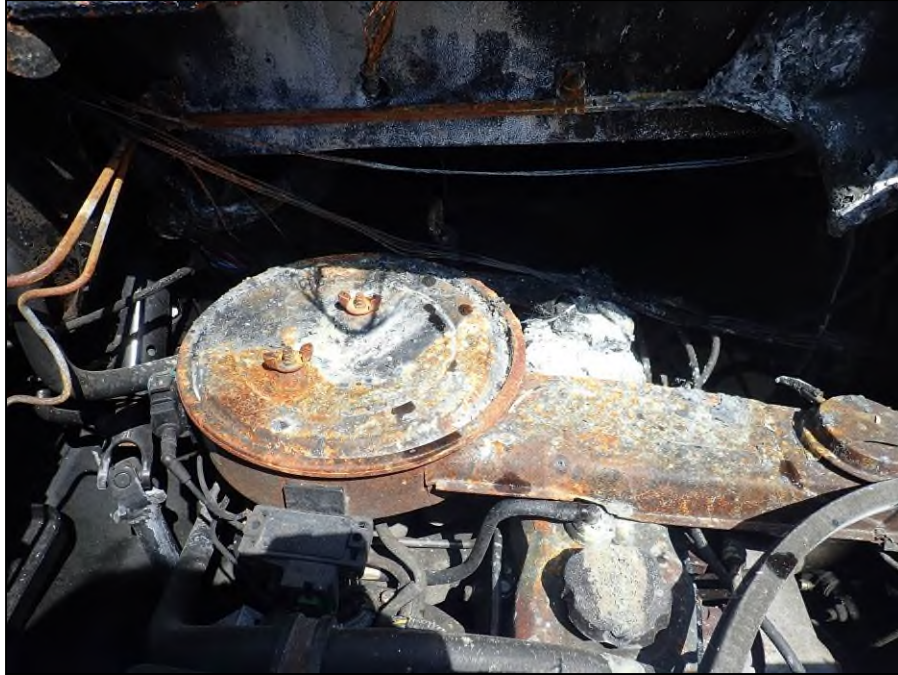
Photograph 5

Fire damage inside engine compartment along bulkhead.

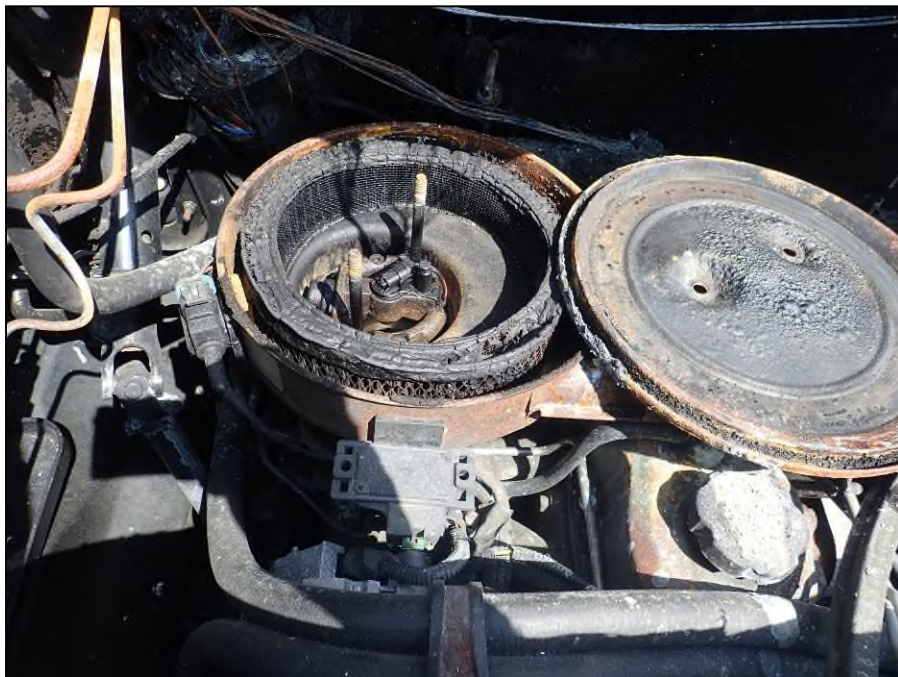
Photograph 6

View inside air cleaner.

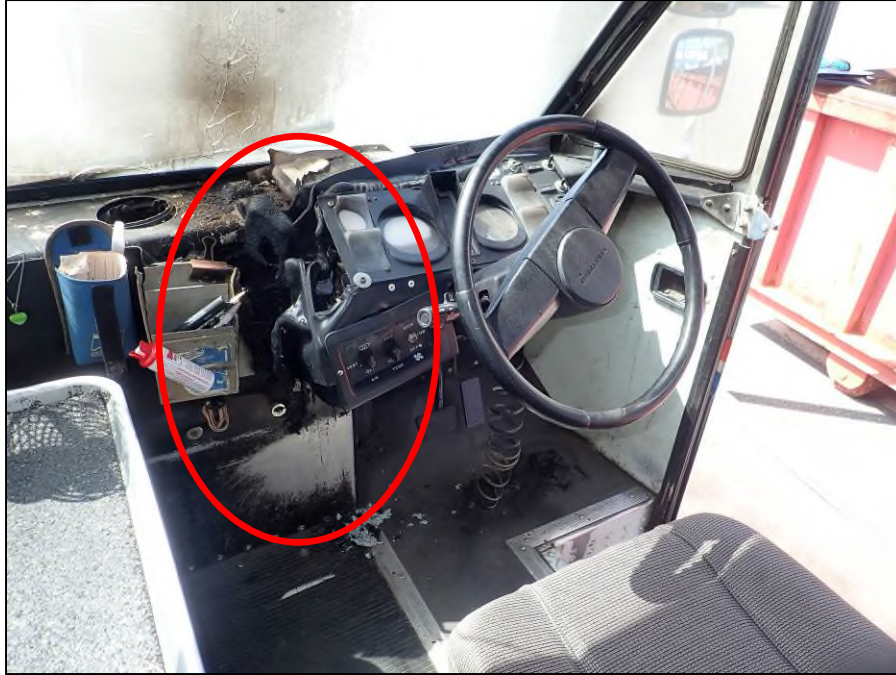
Photograph 7

View of driver's area. Fire damage to dashboard.

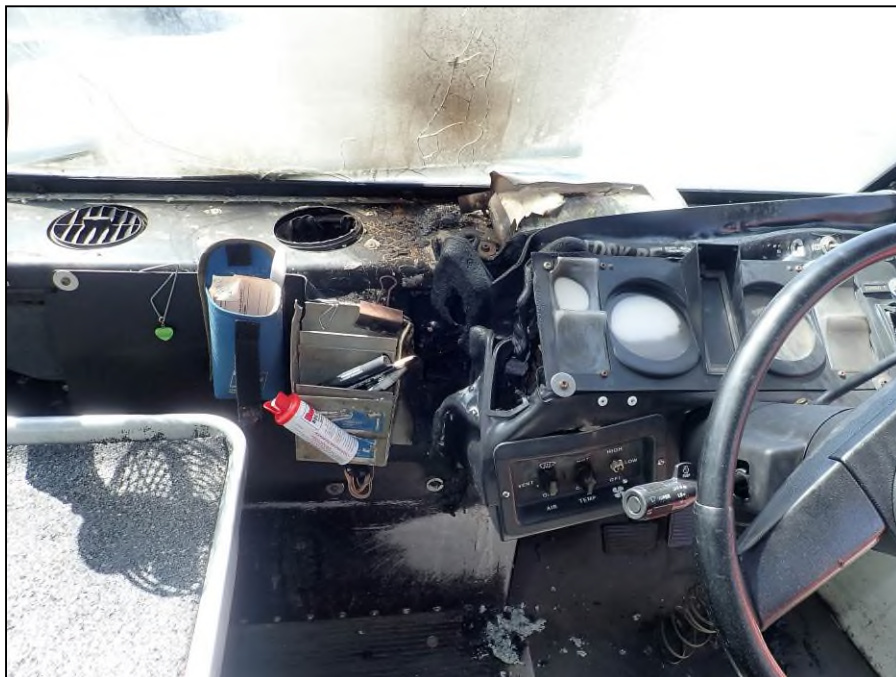
Photograph 8

Fire damage to dashboard.

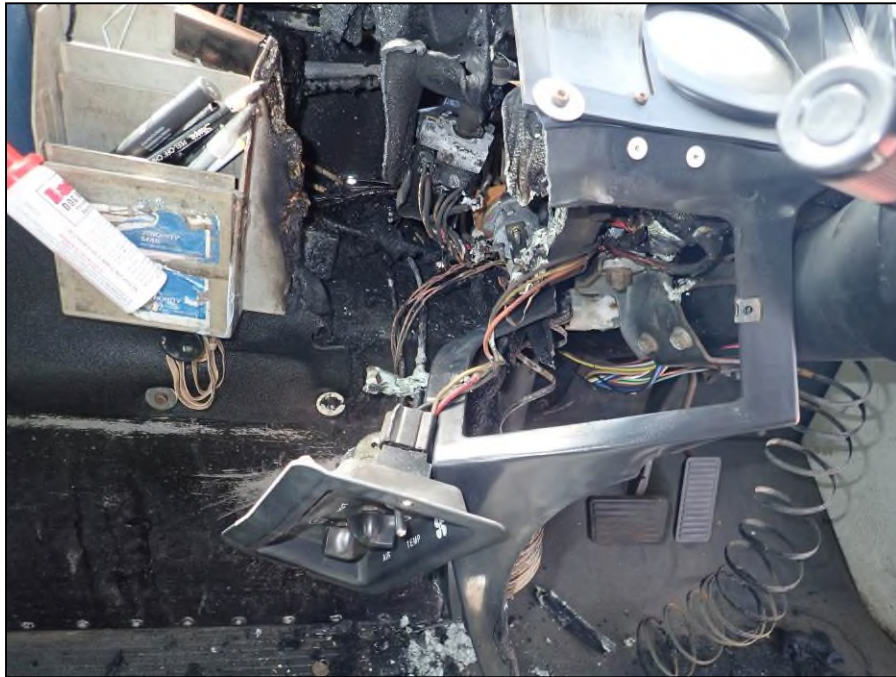
Photograph 9

Closer view of fire damage.

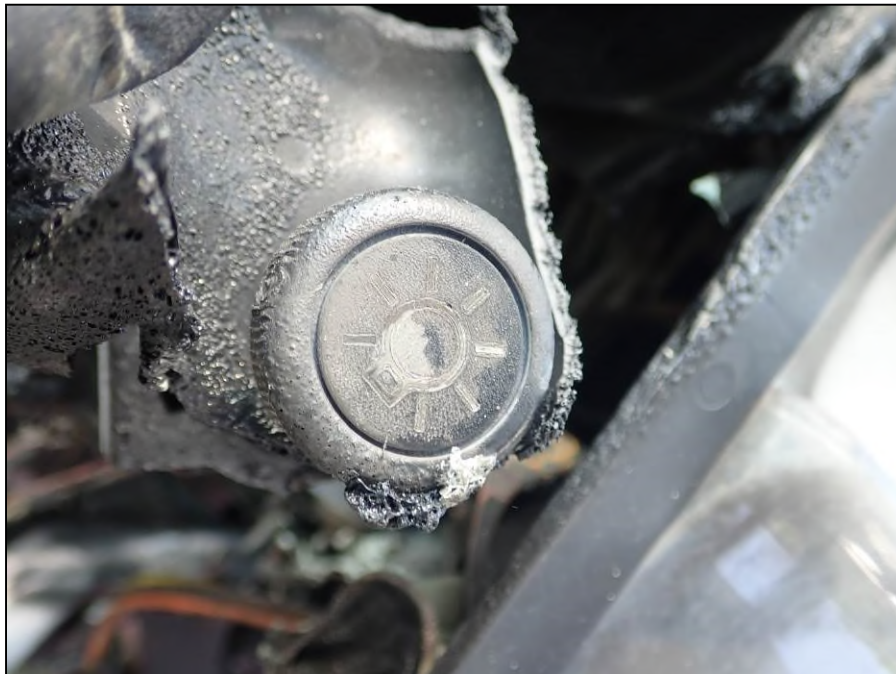
Photograph 10

Headlamp assembly switch.

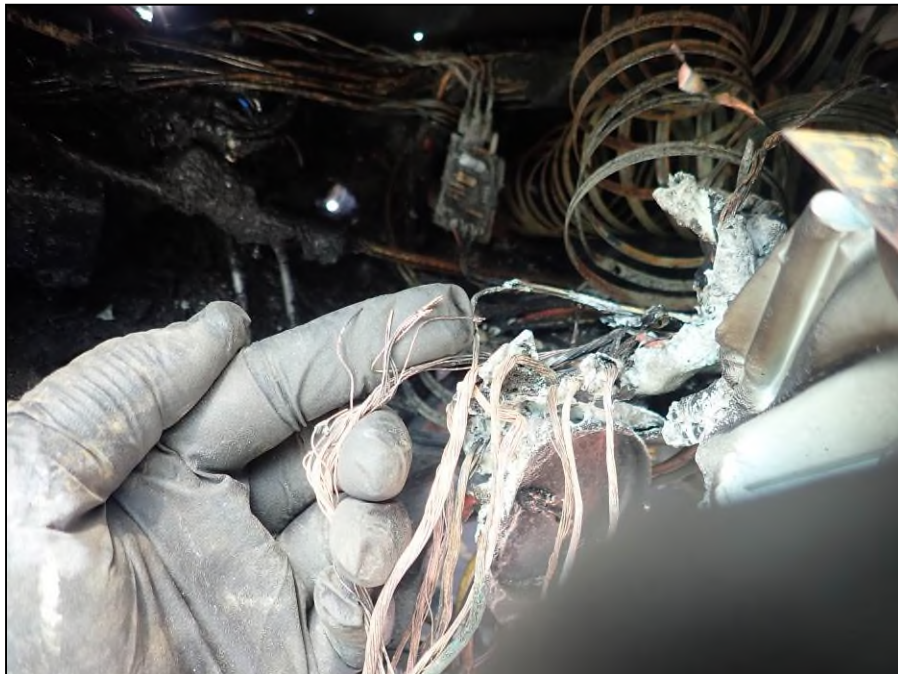
Photograph 12
Abnormal electrical activity of conductors for headlamp assembly.

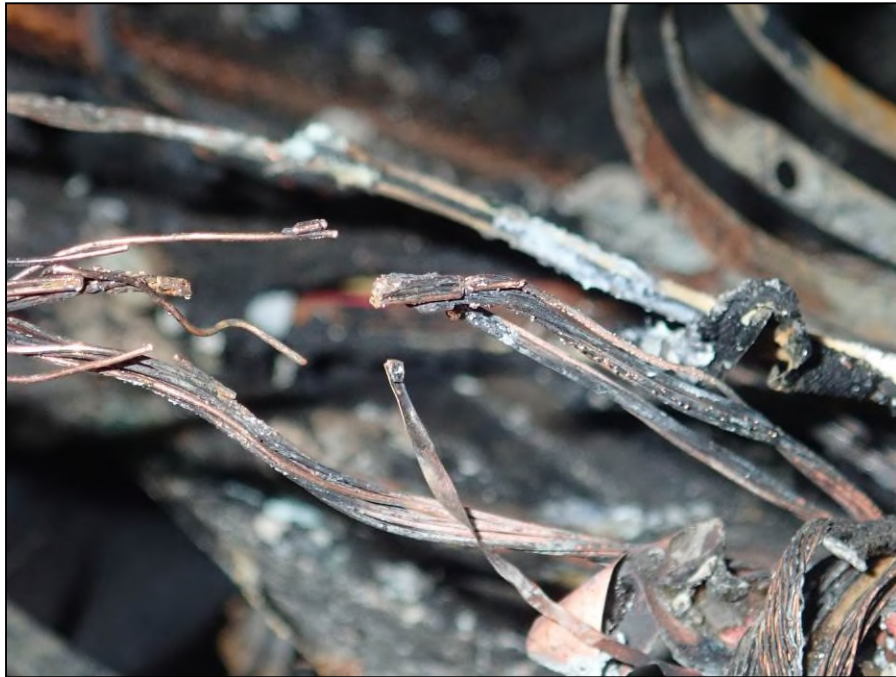
Photograph 13

Abnormal electrical activity of conductors for headlamp assembly.

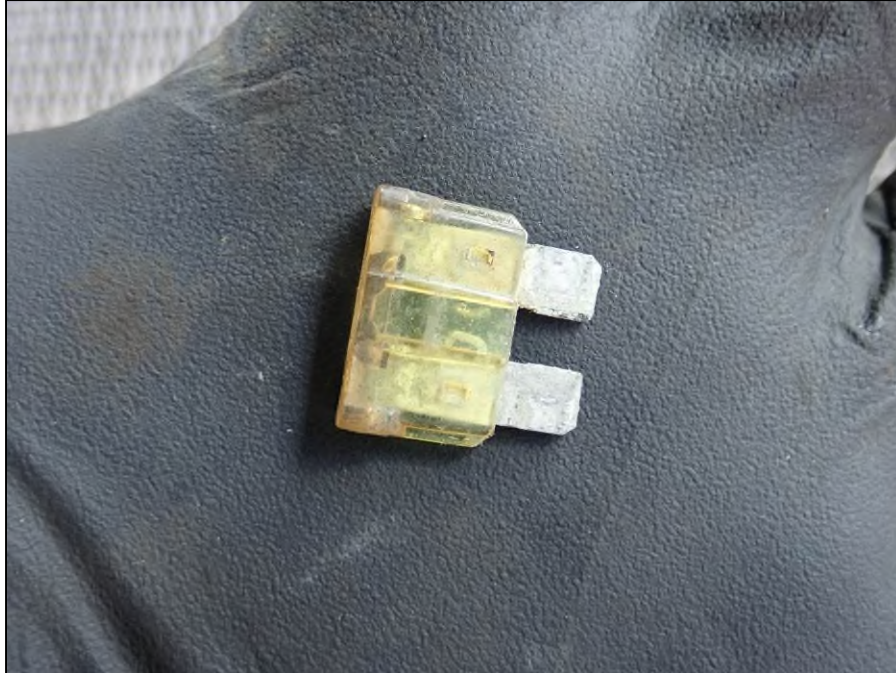
Photograph 15

Fuse removed and blown.

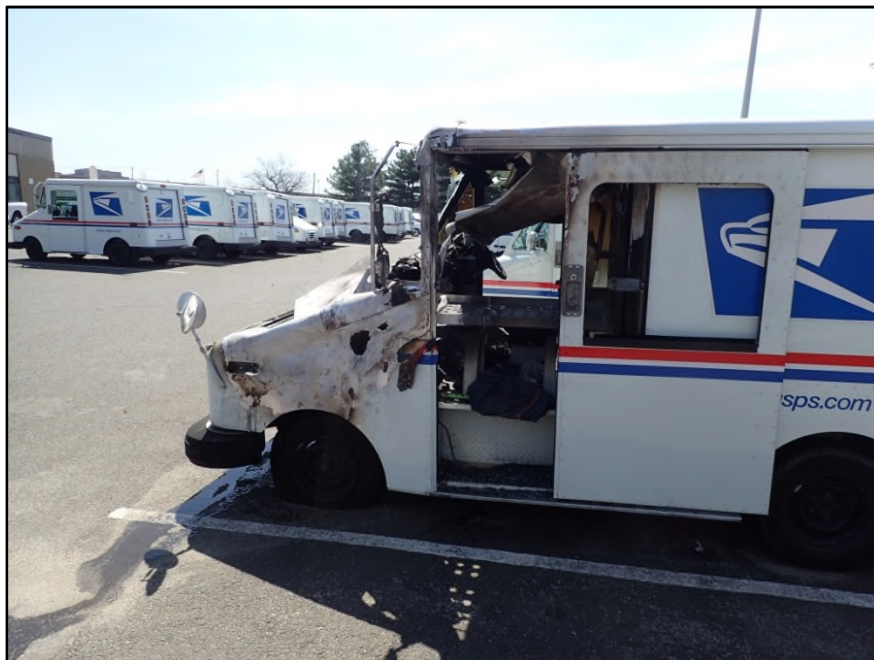
Photograph 2
Fire damage on the mail side of the vehicle.
